Small Commercial HVAC Pilot Program

Final Impact Evaluation

Energy Trust of Oregon

November 23, 2009

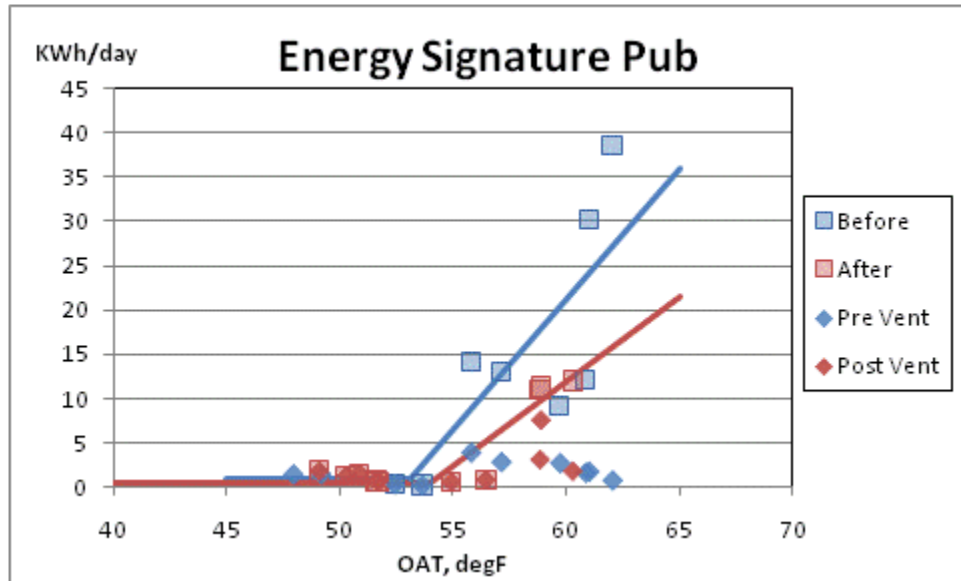
Figure 7. Energy Signature -- Pub

The RTU, together with an identical twin, served the dining area. There were no barriers between the two units so we assumed the same performance for both. The kitchen was served by large exhaust hoods. Makeup air for the kitchen was supplied through a non-functioning evaporative cooler so one expects that these are separate areas for HVAC. These units were greasy and benefited from coil cleaning. We also observed, but did not quantify, a reduction in air leakage. The units already had economizers but they were ineffective due to a lack of 2-stage controls. The treatment included new economizer sensors, with changeover set to 63 degrees and new thermostats with 2-stage controls. Scheduling was improved with night setback.

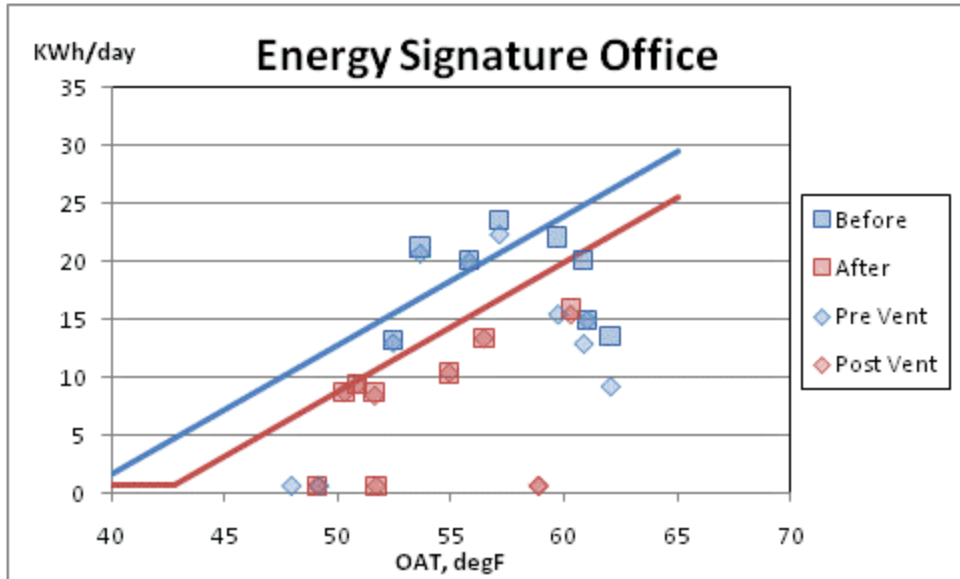
Figure 8. Energy Signature – Office

The RTU, together with an identical twin, served the same area. There were no barriers between the two units so we assumed the same performance for both. The office was occupied five days a week and had fairly high internal gains due to desktop computers. We also observed, but did not quantify, a reduction in air leakage. The treatment included new economizers, with changeover set to 63 degrees and new thermostats with 2-stage controls. Scheduling was improved with night setback.

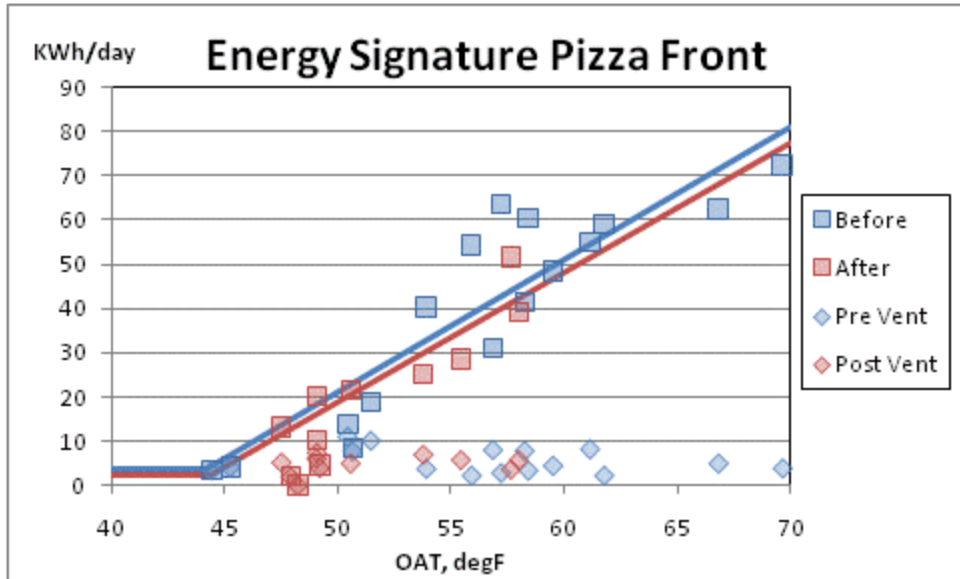
Figure 9. Energy Signature -- Pizza Front

This unit served the front counter for a take-out pizza restaurant. Makeup air is supplied through a non-functioning evaporative cooler so the HVAC system is probably isolated from the kitchen exhaust. This is an older unit and an economizer was not added.

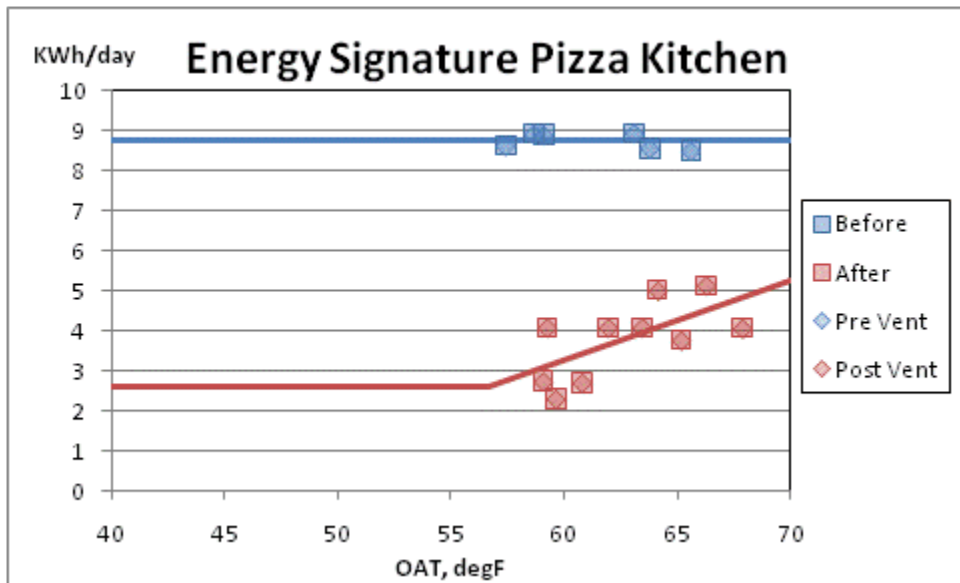
Figure 10. Energy Signature -- Pizza Kitchen

This unit served the kitchen in the same establishment. The supply is located next to a large exhaust hood over the ovens so much of the conditioned air is likely to be exhausted. Coil cleaning was important for this unit due to extensive flour dust. The treatment included new economizers, with changeover set to 63 degrees and new thermostats with 2-stage controls. Scheduling was improved for both units with setback for night and unoccupied days. This store is typically open on Sundays but closed on Mondays.

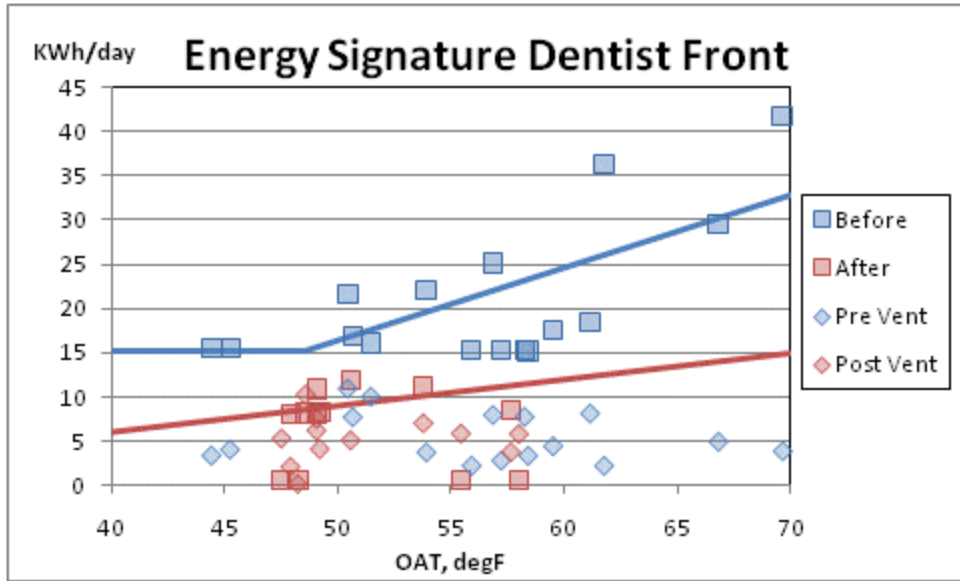
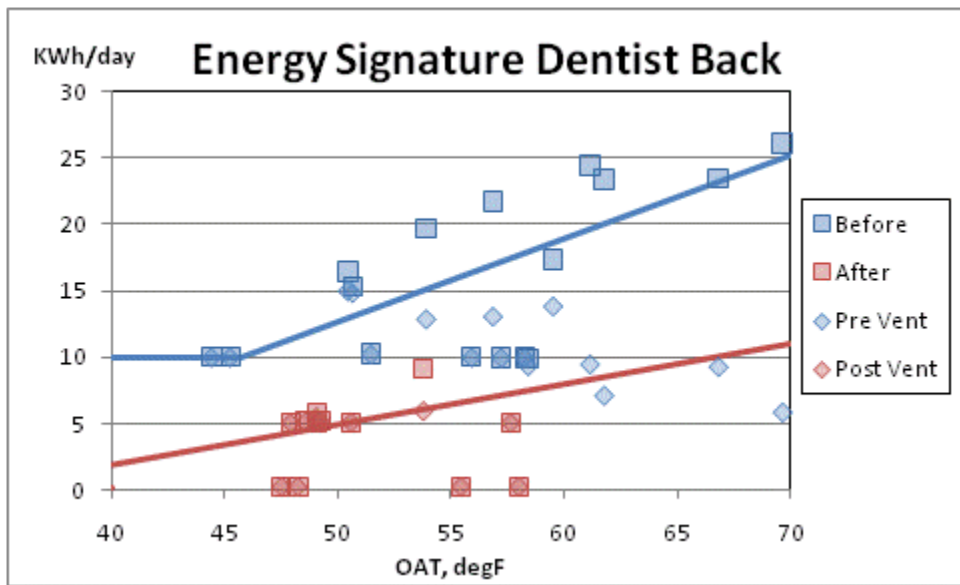
These are identical units serving the front and back area of a dentist office. The treatment included new economizers, with changeover set to 63 degrees and new thermostats with 2-stage controls. Scheduling was improved for both units with setback for night and unoccupied days.

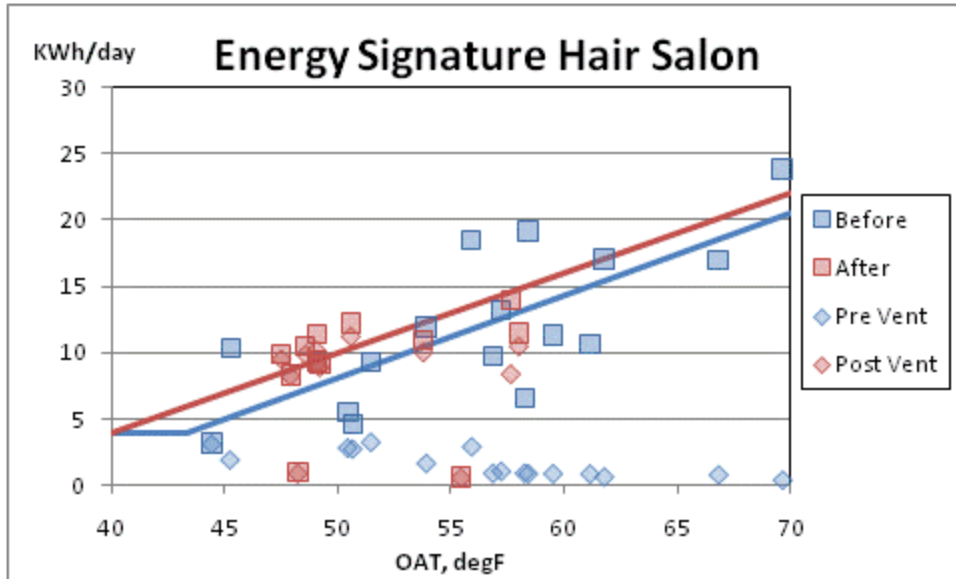
Figure 13. Energy Signature -- Hair Salon

This business needed careful consideration of HVAC requirements. Due to the chemicals used, occupants were concerned about the amount of ventilation air. This was the only unit that had an operating outside air inlet. Even so, they were observed during the study to frequently open the front door in order to get more air. Similarly, they were observed to manually adjust heating and cooling prior to the retrofit. Occupant behavior afterward suggests that they were content with the program scheduling. The treatment included a new economizer, with changeover set to 63 degrees and new thermostat with 2-stage controls. Savings appear to be slightly negative due to increased amount of ventilation with the new scheduling.

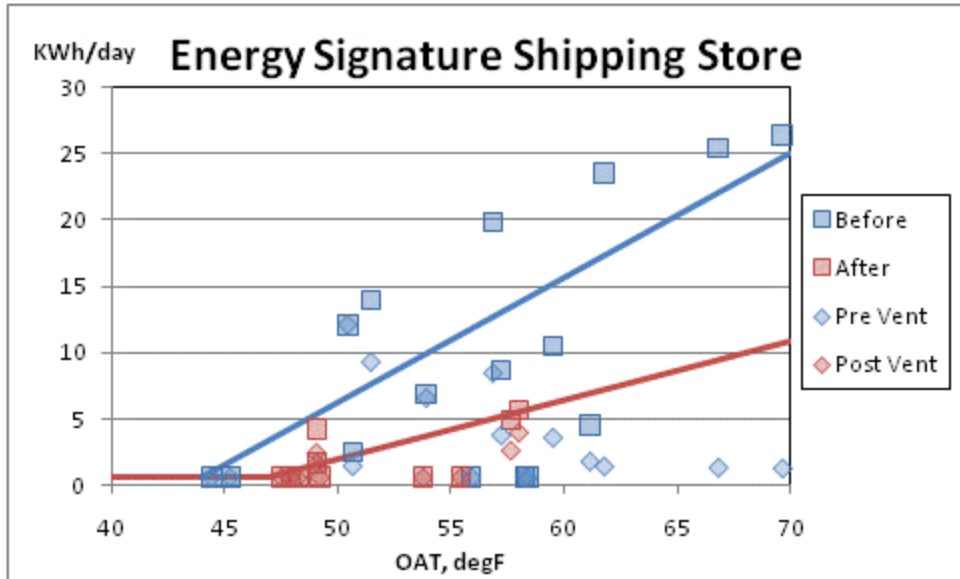
Figure 14. Energy Signature -- Shipping Store

This business provided shipping service and mailboxes. The supply air was located in the front foyer near the mailboxes and was observed to be delivering excessively cold air prior to retrofit. The treatment included a new economizer, with changeover set to 63 degrees and new thermostat with 2-stage controls. Scheduling was improved with setback for night.

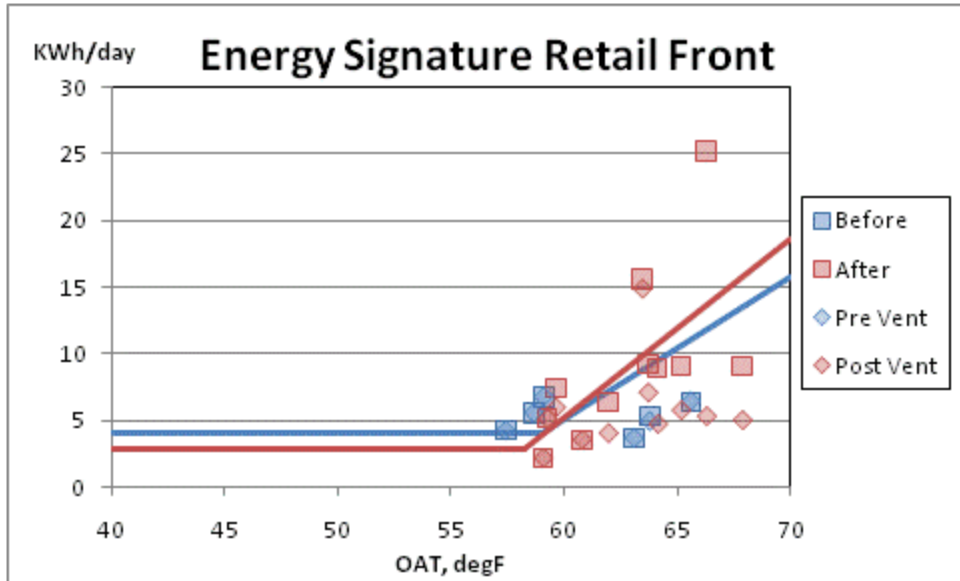
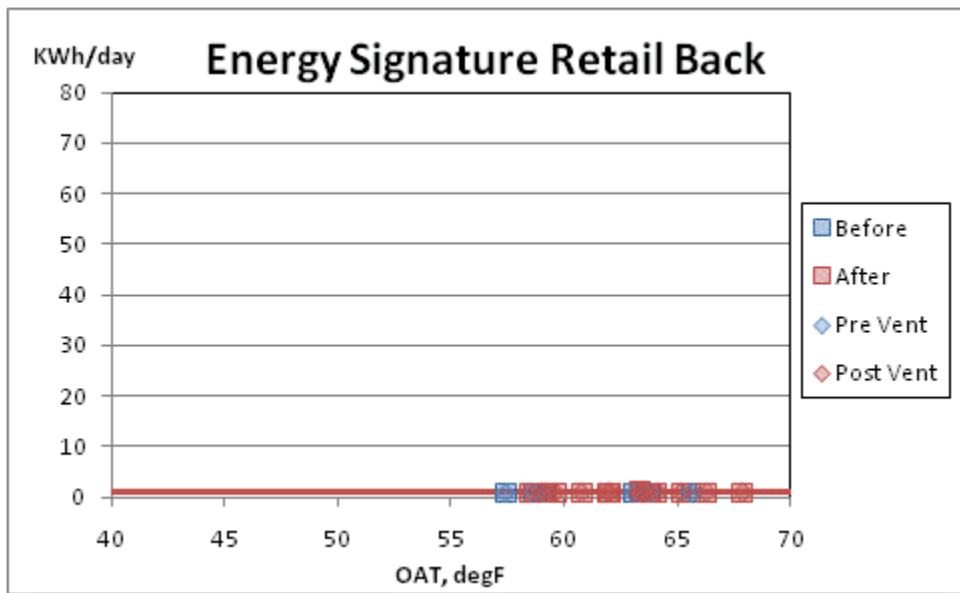
The front unit was the only one that had a functioning economizer prior to the retrofit. This unit served the store area with high ceilings. The treatment included new economizer sensors, with changeover set to 63 degrees and new thermostat. Scheduling added setback for night but without effective savings. The back unit served a stockroom and rarely operated. This was apparent prior to retrofit so the back unit was untreated other than coil cleaning and general checkout.

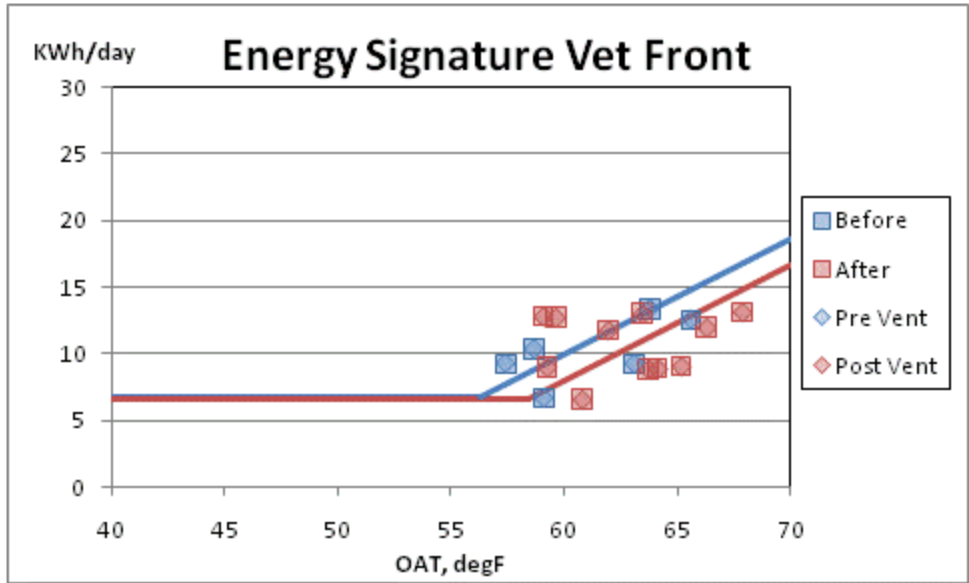
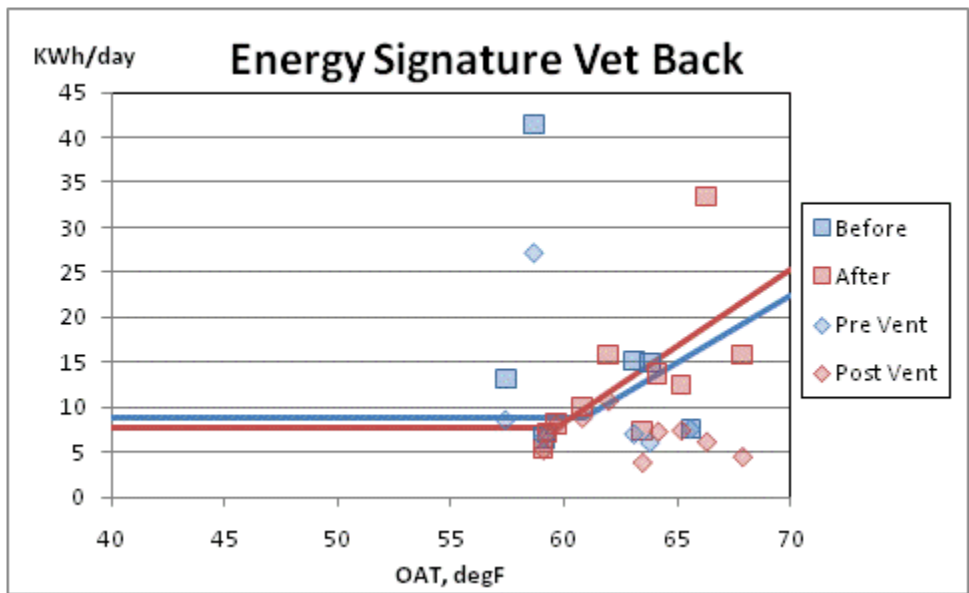
The front area of the veterinary office was served by a large unit with a non-functioning economizer. The back area included kennels for animals and was fully conditioned although often unoccupied. The treatment included new economizer sensors, with changeover set to 63 degrees and new thermostat for both units. This provided modest savings in the front area. The occupant did not want night setback for the back area so there were no effective savings in that area.

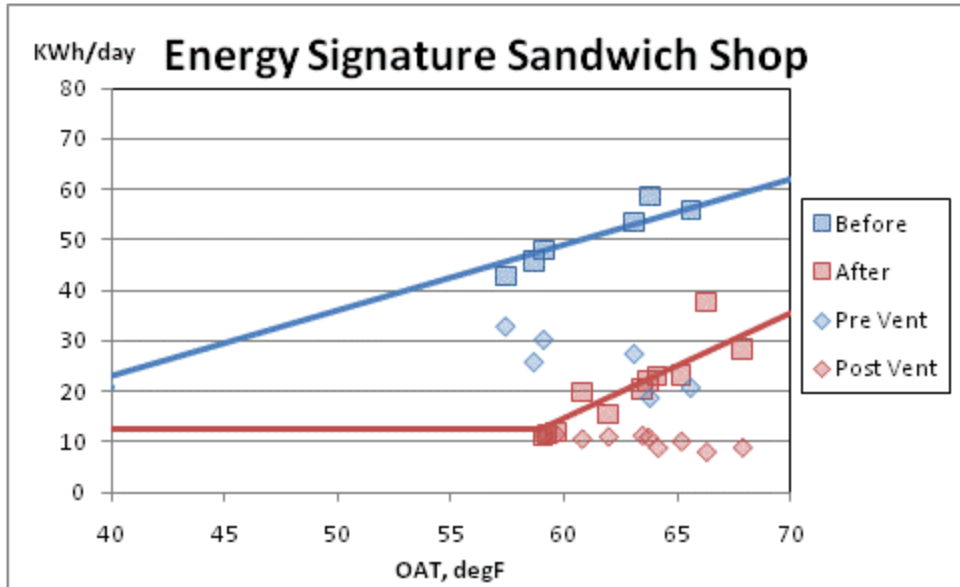
Figure 19. Energy Signature -- Sandwich Shop

This same figure was used in Figure 1 to demonstrate a successful case. There are significant internal gains from ovens so the air conditioning was observed to be in almost constant use. The treatment included new economizer sensors, with changeover set to 63 degrees and new thermostat. Scheduling was improved with setback for night and weekends.
