Small Commercial HVAC Pilot Program

Final Impact Evaluation

Energy Trust of Oregon

November 23, 2009

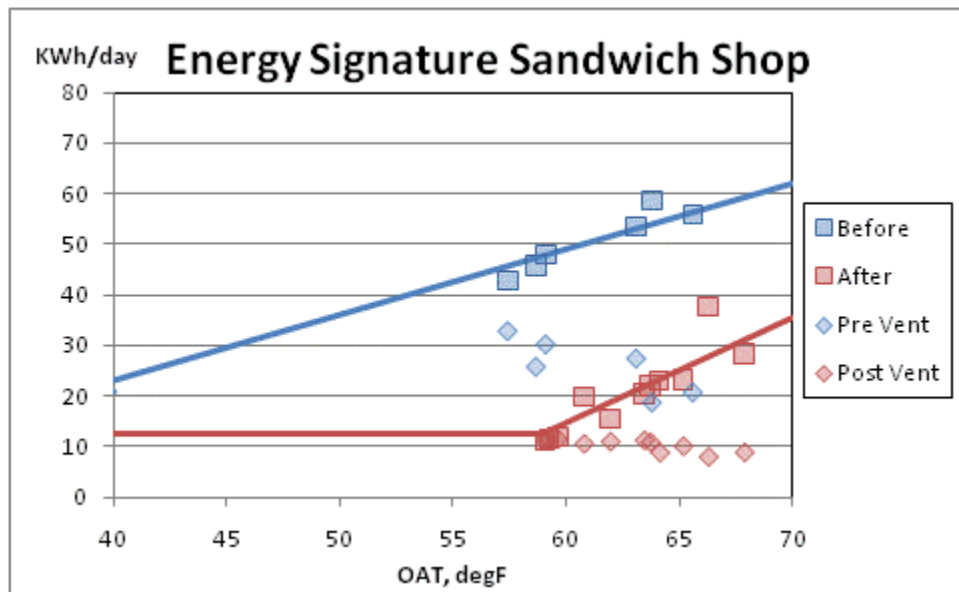
Figure 1. Example Energy Signature Plot

This same figure was used in Figure 1 to demonstrate a successful case. There are significant internal gains from ovens so the air conditioning was observed to be in almost constant use. The treatment included new economizer sensors, with changeover set to 63 degrees and new thermostat. Scheduling was improved with setback for night and weekends.

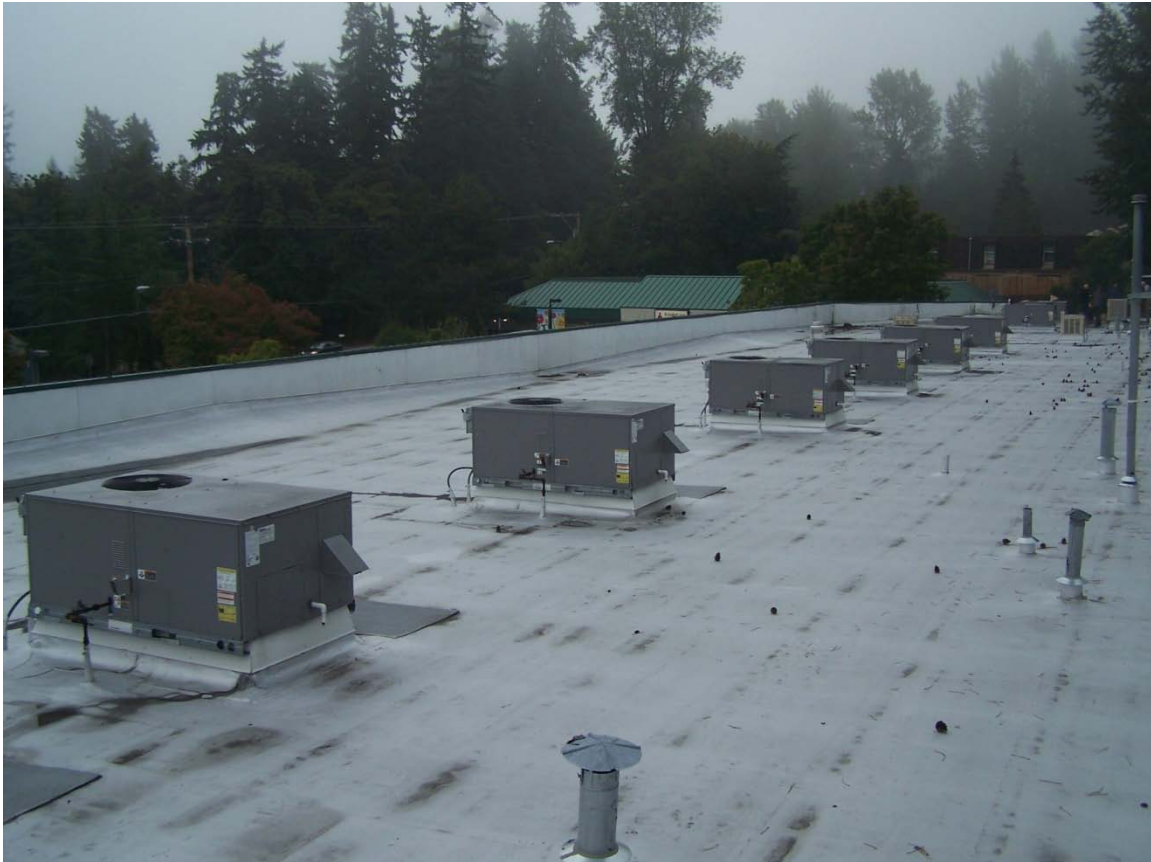
Figure 2. Site Layout

The monitoring part of the project focused on one location. This building is a strip mall containing a representative mix of small business types. Included are two sit-down restaurants, a fast food outlet, a retail store, an office and professional services (dentist, veterinarian, hair salon). We skipped one vacant space and one space (a dry cleaner) did not have a packaged HVAC unit. Otherwise, the businesses all had essentially the same HVAC system consisting of a rooftop packaged HVAC unit that discharged directly into the space below. This location was appealing because it was easy to direct the contractor to just follow the same standard repair protocol on all units. Figure 2 shows how the site consists of a row of essentially the same HVAC unit.

Three of the HVAC units already had economizers. However, only one was functional. The other two units did not have two-stage controls. For the existing economizers, the installation included installing proper controls, new temperature sensors and proper specification of the economizer change over temperature. The other units received a drop-in economizer with the exception of one seldom-used unit that served only a stock room in the retail space.

To our surprise, the repair visit revealed that, with one exception, outside ventilation was disabled on all the units. The outside air intake vents were physically locked shut. This means that most of the businesses were not receiving sufficient air for ventilation.

The HVAC units were mounted in a roof curb that lacked proper sealing. Thus, there was noticeable air leakage around the curb on several units. The contractor installed a curb seal on all the units that successfully reduced leakage. However, no measurements were made to quantify the exact amount of leakage.
